LAKE CLASSIFICATION SHORT REPORT ON MASON LAKE, ADAMS COUNTY, WI

**Presented by Reesa Evans, Lake Specialist
Adams County Land & Water Conservation Department
P.O. Box 287, Friendship, WI 53934**

OCTOBER 2007

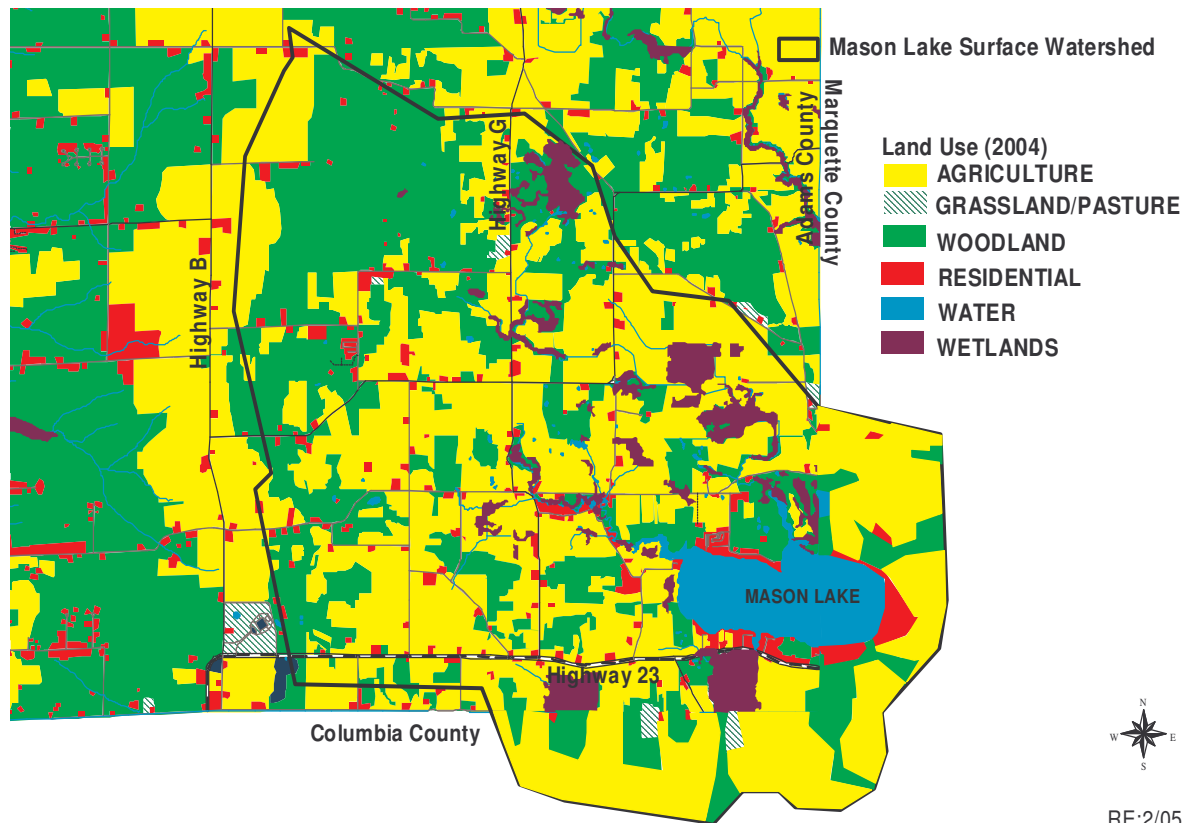
LAND USE IN MASON LAKE SURFACE WATERSHED

There are several wetlands (seen in purple on the land use map) in the watershed. Indeed, part of Mason Lake is a flooded wetland. Wetlands play an important role in water quality by trapping many pollutants in runoff waters and by serving as buffers to catch and control what would otherwise be uncontrolled water and pollutants. Wetlands also play an essential role in the aquatic food chain, thus affecting fishery, and also serve as spaces for wildlife habitat, wildlife reproduction & nesting, and wildlife food. It is essential to preserve these wetlands for the health of Mason Lake waters.

The surface watershed for Mason Lake is large. The bulk of the watershed (57.8%) is in agricultural use; second largest land use is woodlands (31.7%). Residential use tends to be scattered, except for around the lake itself. Studies have shown that a lake is the product of its watersheds, with land use around a lake having a great impact on the water quality of that lake, especially in the amount and content of stormwater runoff from the surface. Stormwater runoff volume is affected by the amount of impervious surface, the soil type and the slope of the area. Natural landscapes tend to have low runoff rates.

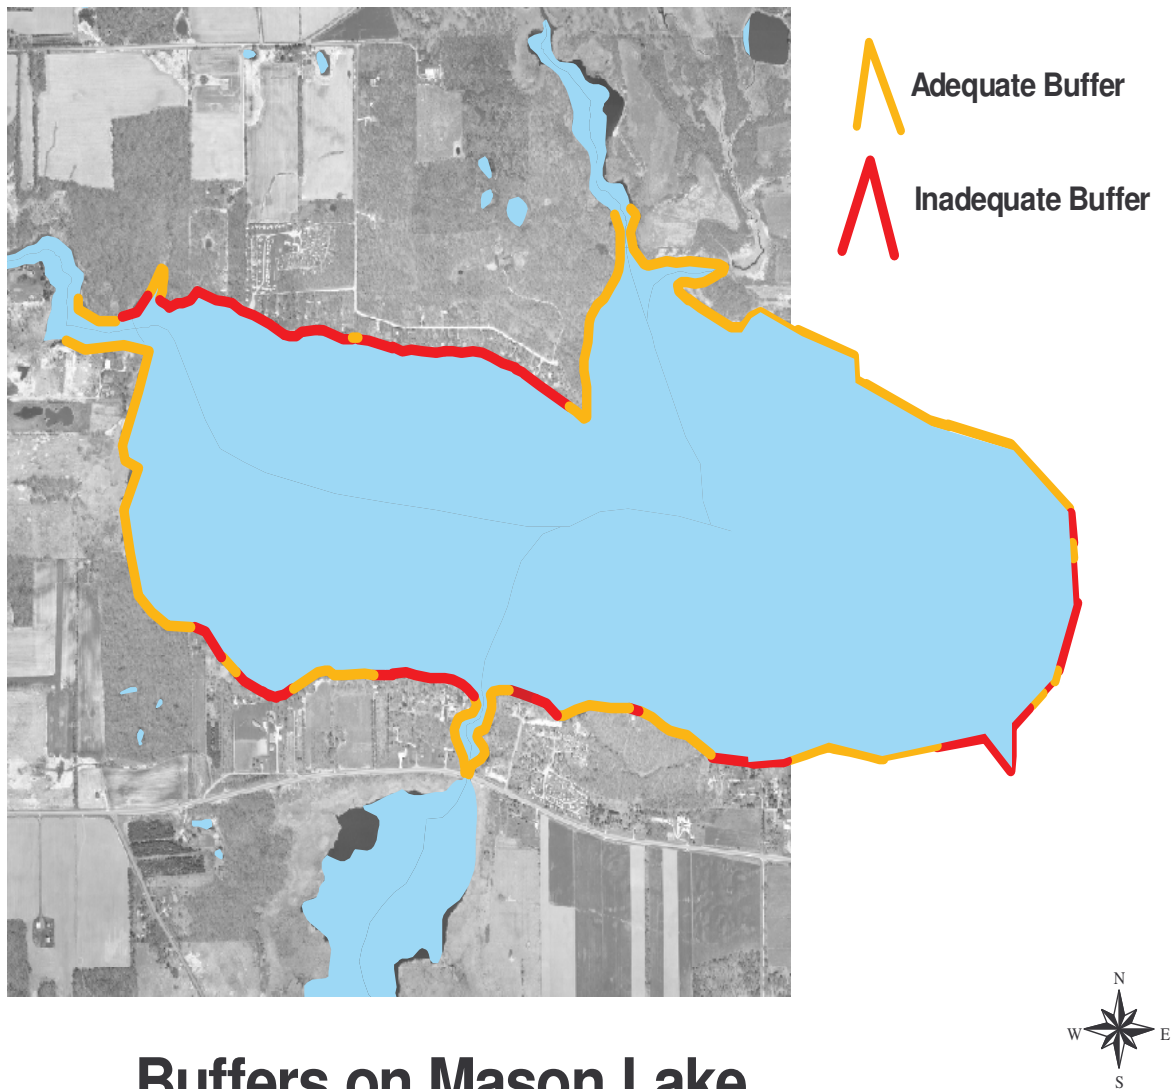
Buffers on Mason Lake

A 2004 shore survey showed that only about 1/2 of the shore had an “adequate buffer.” An “adequate buffer” is a native vegetation strip at least 35 feet landward from the shore. Most of the “inadequate” buffer areas were those with mowed lawns insufficient native vegetation at the shoreline to cover 35 feet landward from the water line, and/or seawalls or rock.

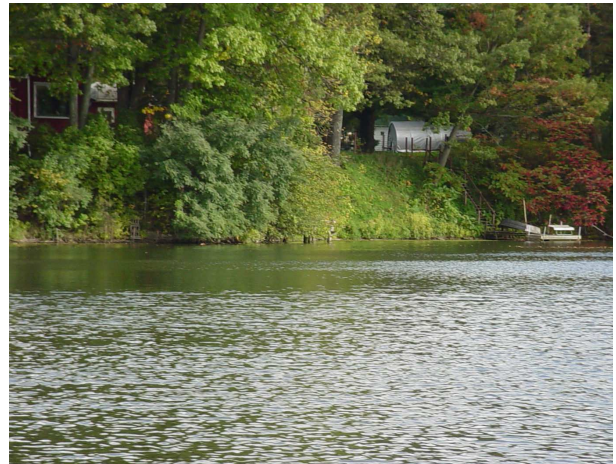
Example of Adequate Buffer

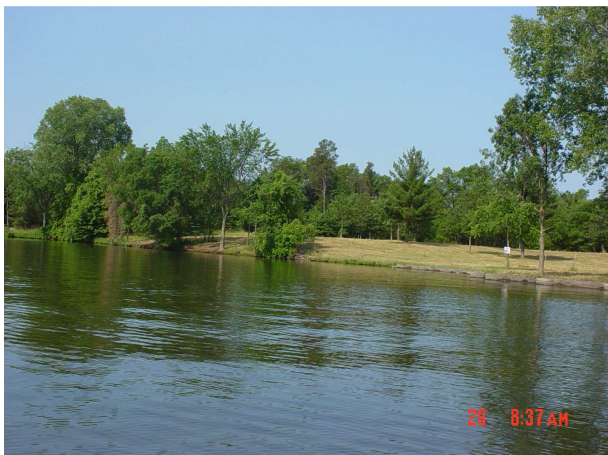
Example of Inadequate Buffer

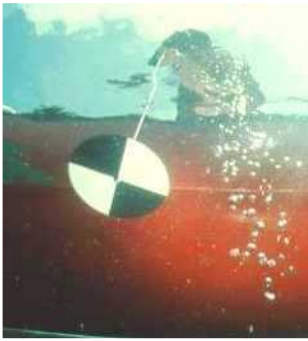
Water clarity readings are usually taken by using a Secchi disk (shown at right). Average summer Secchi disk clarity in Mason Lake in 2004-2006 was 2.5 feet. Records since 1987 show that this water clarity reading is less than the average in the late 1980s. This is probably as a result of the problems noted in the 303(d) classification: highly-elevated phosphorus level, eutrophication, pH problems, NPS contamination and degraded habitat

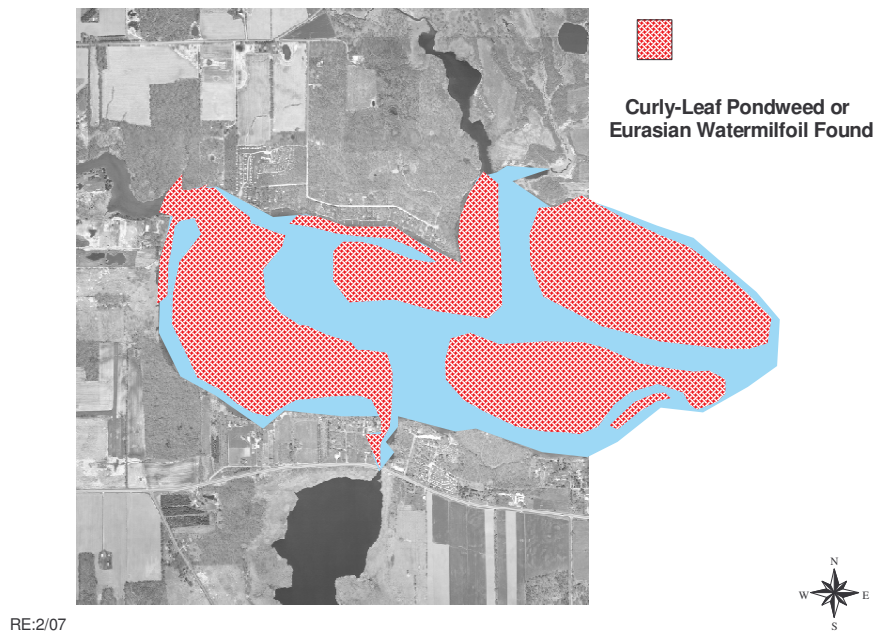
Exotics in Mason Lake 2005

Important to maintaining a quality, diverse aquatic plant community is an integrated aquatic plant management plan that controls the invasive plants in the lake. Both Eurasian watermilfoil and *Potamogeton crispus* (curly-leaf pondweed) have risen to nuisance levels in Mason Lake, but when comparing the results of the 2005 survey to the 2001 survey, both had declined in density and occurrence frequency. Diversity had also increased.

- The Mason Lake District should maintain exotic species signs at the boat landings and contact DNR if the signs are missing or damaged.
- The Mason Lake District should monitor Eurasian Watermilfoil and Curly-Leaf Pondweed and take steps to maintain the most effective (and multiple) methods and modify them if necessary. Residents should hand-pull scattered plants.

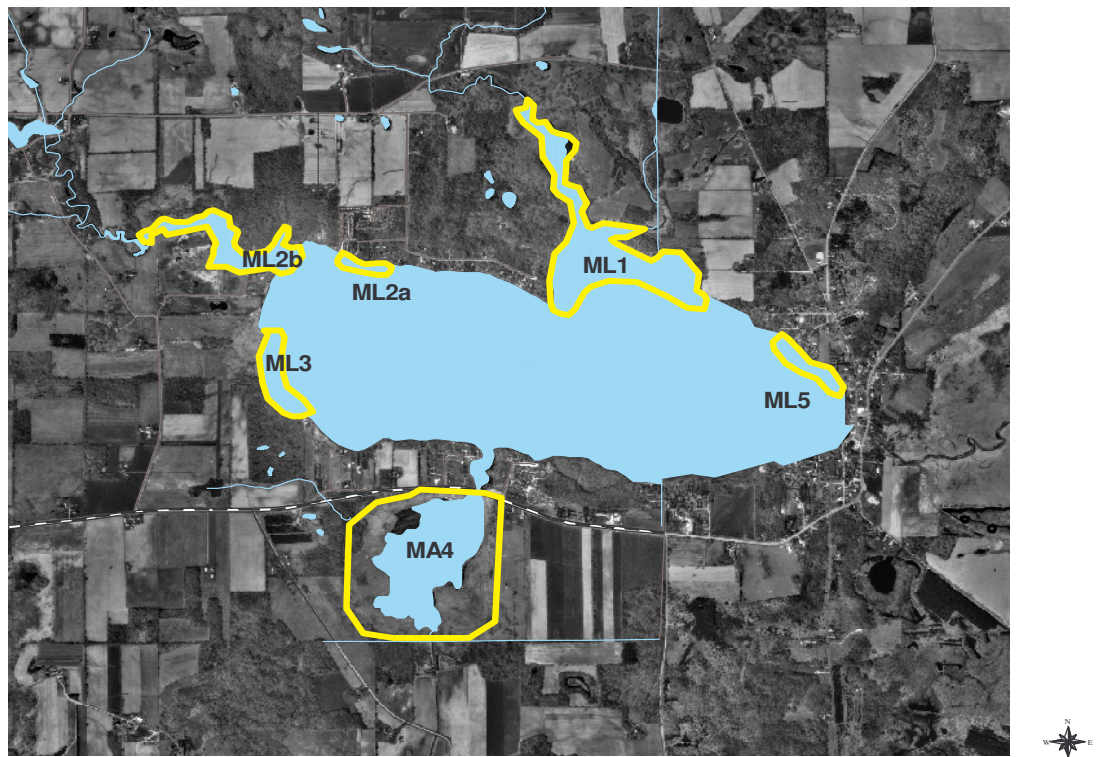
Critical Habitats: Mason Lake

Five areas on Mason Lake were determined to be appropriate for critical habitat designation. ML1 extends along approximately 4000 feet of shore in Burn's Cove and up into the stream, up to the ordinary high water mark. ML2a is approximately 600 feet of the northwest shoreline. ML2b is 800 feet of lakeshore at the Big Spring Inlet and up into the tributary. ML3 extends along 2000 feet of shoreline at the west end of the lake and is a wetland area. ML4 includes all of Amey's Pond & the area immediately around it. Finally, Area ML5 goes along 1000 feet of shoreline at the northeast end of the Mason Lake and protects a fish spawning area.

- Maintain current habitat for fish and wildlife.
- Leave fallen trees along shoreline & in water.
- Seasonal protection of spawning habitat. No disturbance of the littoral zone except for access/viewing corridor and/or WDNR-approved projects.
- Maintain the wildlife corridor.
- Maintain sedge meadow/deep marshes areas. Re-establish wild rice beds, if possible.
- Protection emergent vegetation.
- Seasonal control of exotics. Continued monitoring for exotics.
- No bank grading or grading of adjacent land. Use of bioengineering practices only in instances of bank protection.
- Any additional piers that are installed should be minimal in number and use only light-penetrating material.
- Maintain aquatic vegetation in undisturbed condition for wildlife habitat, fish use and water quality protection.
- Make critical habitat areas “no wake” areas to reduce disturbance to these areas.
